Building Number: 7

Original Name: Water Control Building
(Water Plant)
(Water Treatment Plant)

Est. Year of Construction: 1951

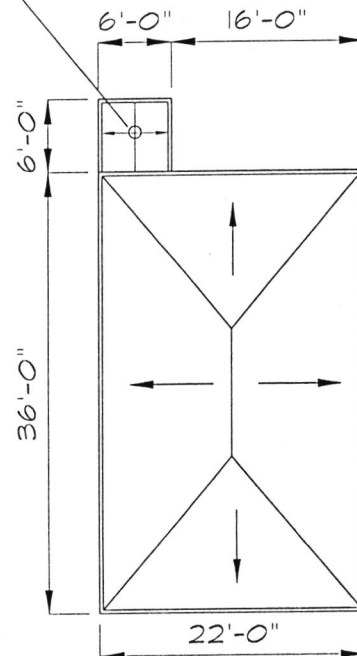
2x4 NOM. RAFTERS
@ 16" O.C.

WALLS
8" CMU

FLOOR
CONCRETE SLAB
ON GRADE

2x6 NOM. TOP & BOTTOM
TRUSSED RAFTERS @ 24" O.C.
